CARBON SIX
HOME INSPECTIONS

Sample Home Inspection Report

2112 Walnut Ct.
Walnut Hills ST
12345

Date of Inspection: 10/22/2015

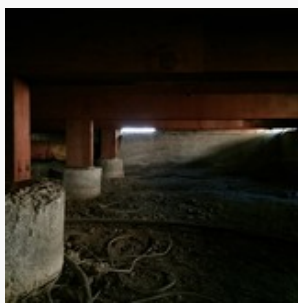
The house is supported by a pillar and post foundation system, all appears in good serviceable condition.

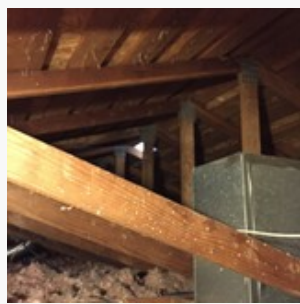
No evidence of water stains or damage.

The existing attic has 2 x 4 truss frames with skip sheathing. The skip sheathing has been over layed with OSB sheer panels to bring the building to current seismic requirements.

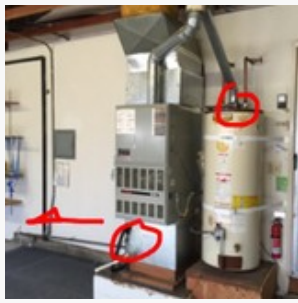
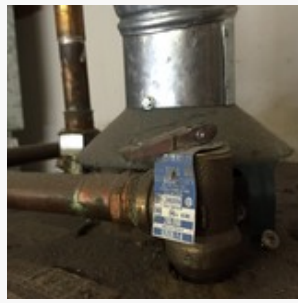
The drain from the hot water heater is combined with the condensate drain for the air conditioning system to a common, sloped, copper pipe extending to the exterior through the back wall of the garage.

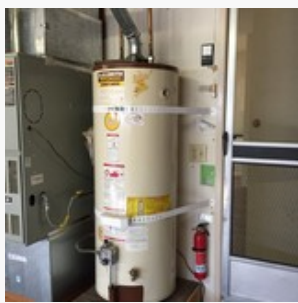
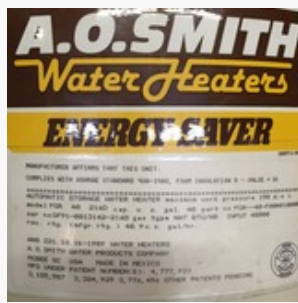
40 gallon hot water heater, in serviceable condition, with proper seismic straps.

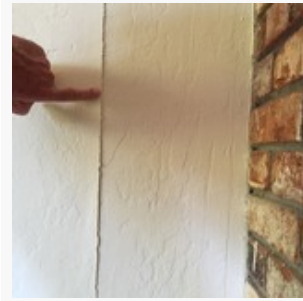
[Photo] Vertical crack in the gypsum wallboard adjacent to fireplace. Recommend monitoring to see no settlement is occurring.

Vertical crack in the gypsum wallboard adjacent to fireplace. Recommend monitoring to see no settlement is occurring.
10/22/2015 20:19 (UTC)

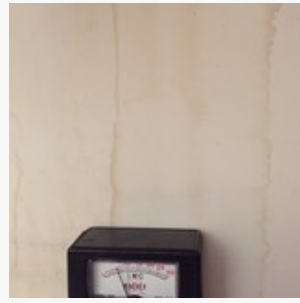
Water stains under the basin.
However, checking with the
moisture meter, no evidence of
any dampness or wetness in the
wall.

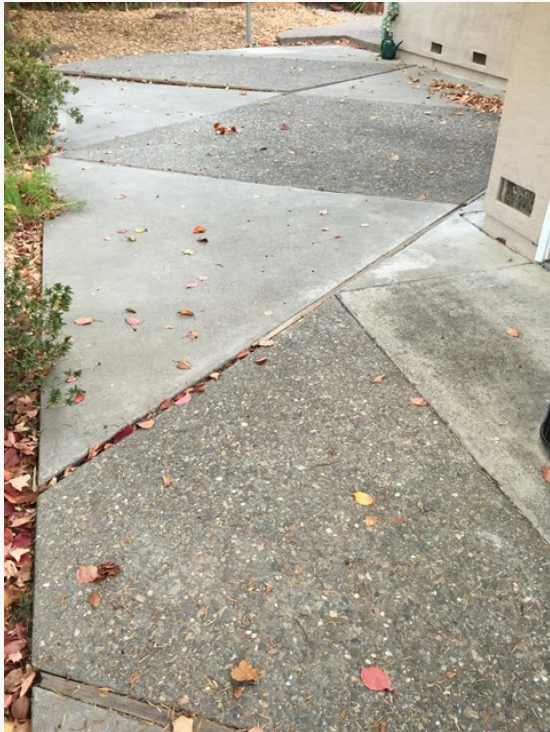
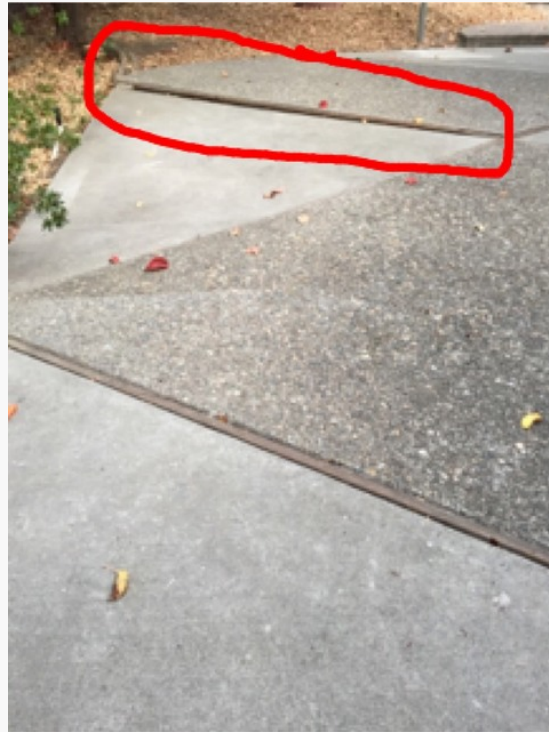
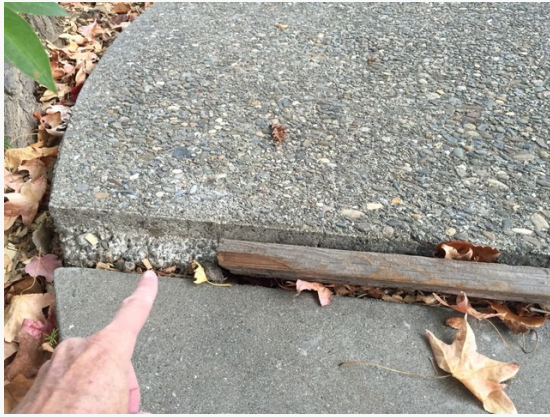
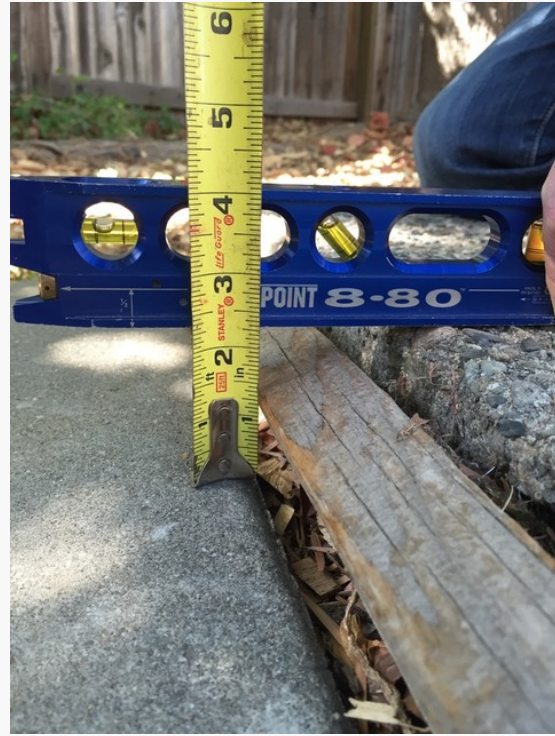
Hardscape in serviceable condition. Unevenness which is a tripping hazard was noted. Likely tree root-related upheaval. [Photo] Concrete slab is heaved about 2-1/4".

Hardscape in serviceable condition. Unevenness which is a tripping hazard was noted. Likely tree root-related upheaval.

Concrete slab is heaved about 2-1/4".
10/22/2015 20:06 (UTC)

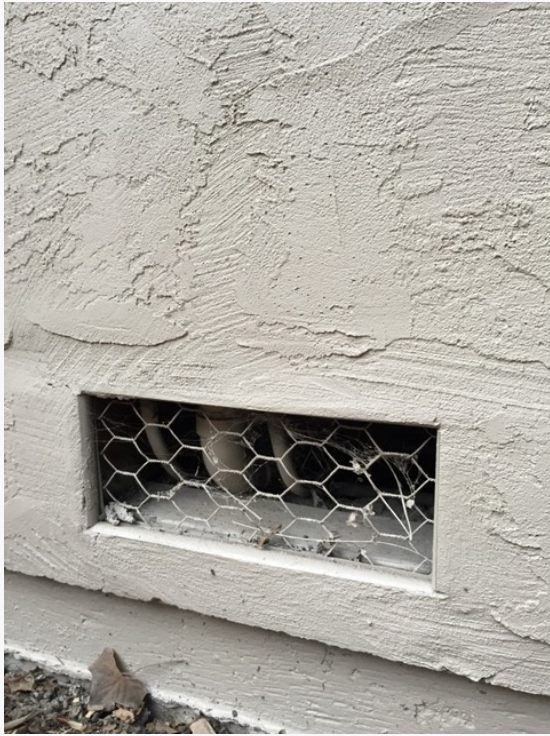
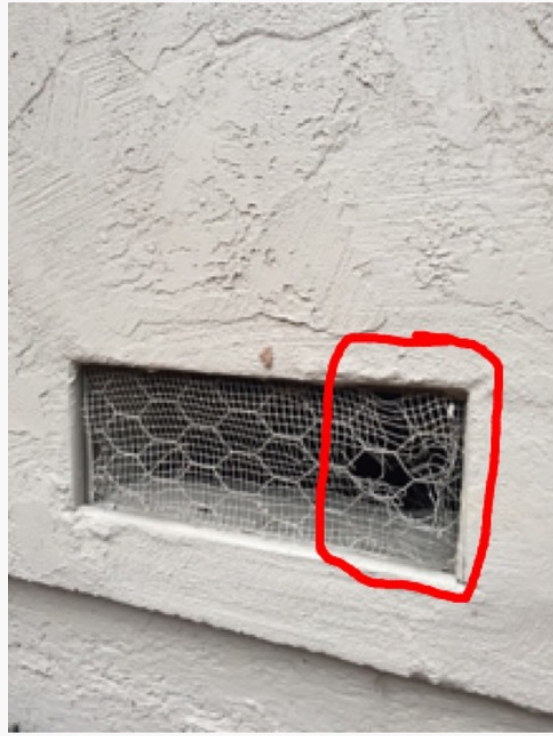
Right Elevation: Siding/Trim

Crawl space vents fine wire mesh to control rodent access is missing or damaged.

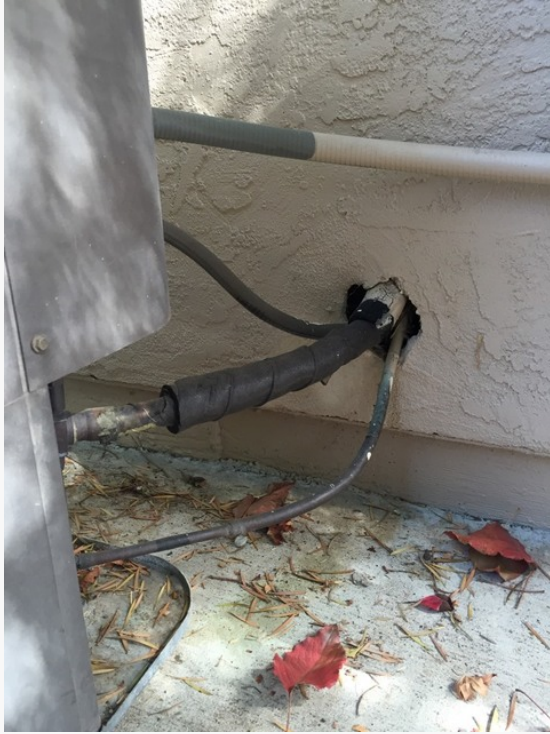
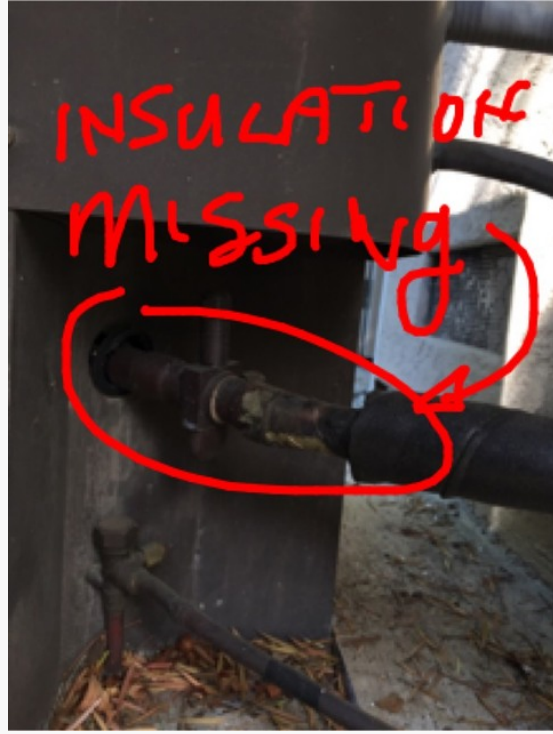
Heating And Cooling: Refrigerant Lines

[Photo] Refrigerant lines penetrating the stucco, the open gap, should be sealed.

Refrigerant lines penetrating the stucco, the open gap, should be sealed.

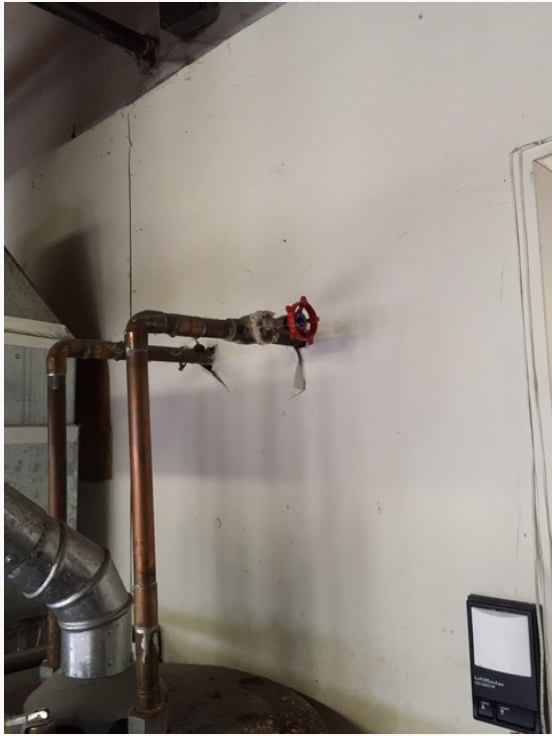
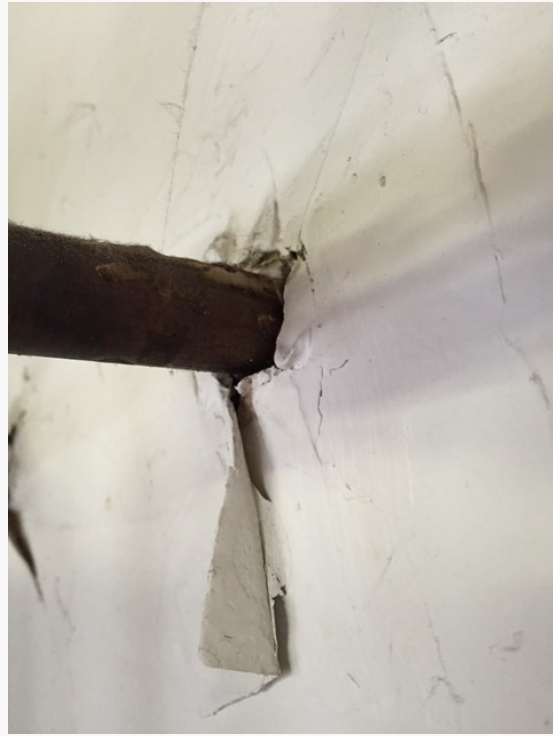
Garage: Walls

Water pipes penetrating the 1-hour firewall from the garage to the living space do not have fire-stopping material.
