Project: St James Church

Client: Jersey Property Holdings
Architect: Andrew Harvey

Description:

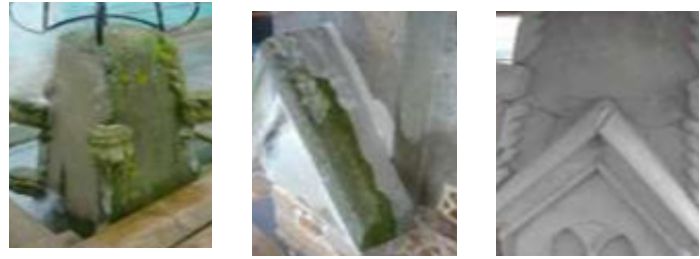
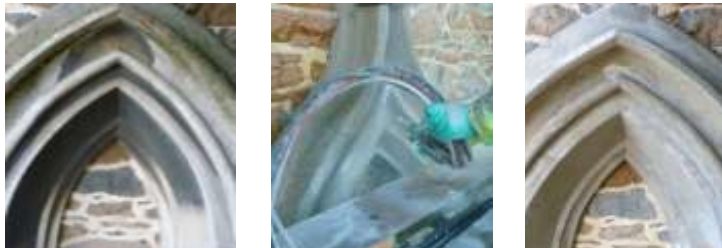
DOFF system:

The building was heavily soiled, especially on the rendered and stone elements at the top of the building. There was a combination of biological growth on the more exposed portions and accumulation of carbon residue/staining on the more sheltered portions. Two specialist systems, designed for gentle but effective cleaning of conservation projects, were employed to affect the cleaning of the building.

The superheated water system that enables the user to use a combination of low pressure and high temperature (up to 150° C) to remove engrained dirt and biological matter. (see photos right).

The TORC system creates a gentle swirling vortex using a mixture of low air pressure, little water and a safe inert fine granulate. It was used here to remove the carbon build-up found in the more sheltered corners of the architectural detailing (see photos left).

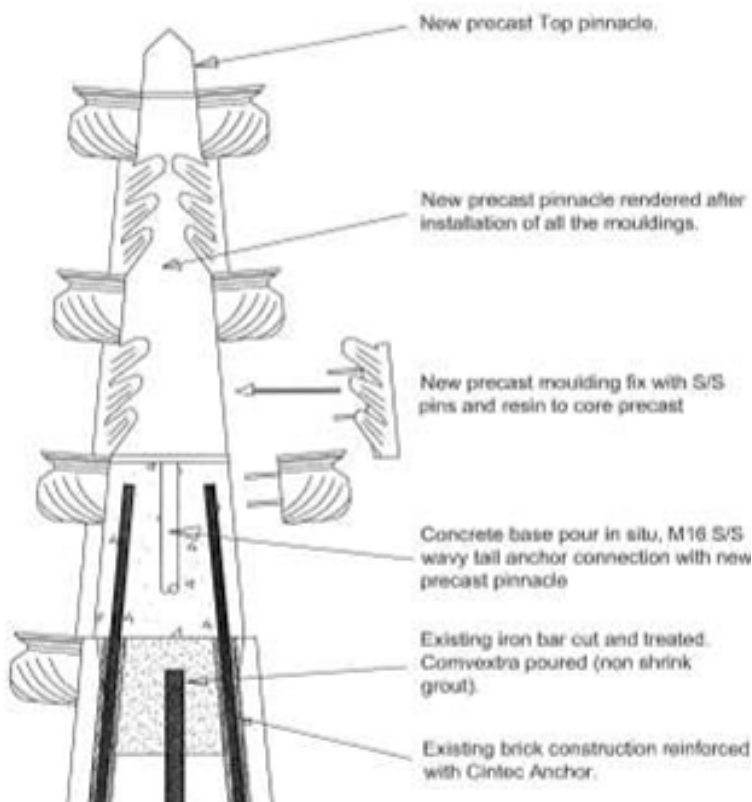
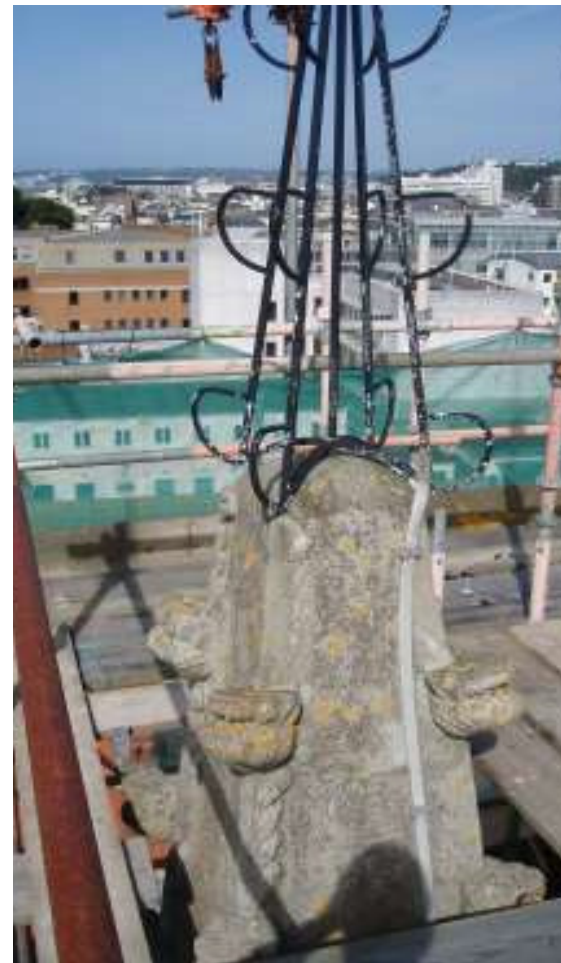
Pinnacles - Upper Part Rebuilt:

After the completion of the cleaning stage it was discovered that the 8 top pinnacles were in a very bad condition and had to be structurally reinforced.

The pinnacles were reduced down (1) to 400mm. The existing iron bars were cut (2) and treated and the COMBEXTRA (non-shrinking grout) was poured. Then Cintec Anchors (3) were

installed by Geomarine and the reinforced limecrete caps poured in-situ (4). Installation of the top piece then followed by resin anchoring a stainless steel bar into the cap (5), (lime: cement and sand (1:1:6)). Then the new cast mouldings were in- stalled (6) and a final render coat applied over stainless steel mesh (7), (see photos 1-patric7).

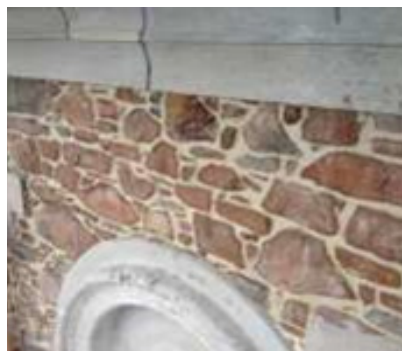
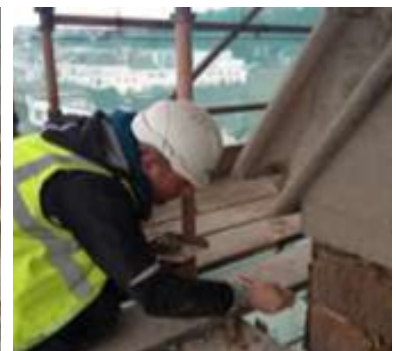
Central Finial:

The central finial between the two towers on level 8 were in poor condition. There was extensive cracking and the top portion had fallen away. The structural engineer decided to keep the finial and re-stabilise it rather than replacing the entire portion. See photos left.

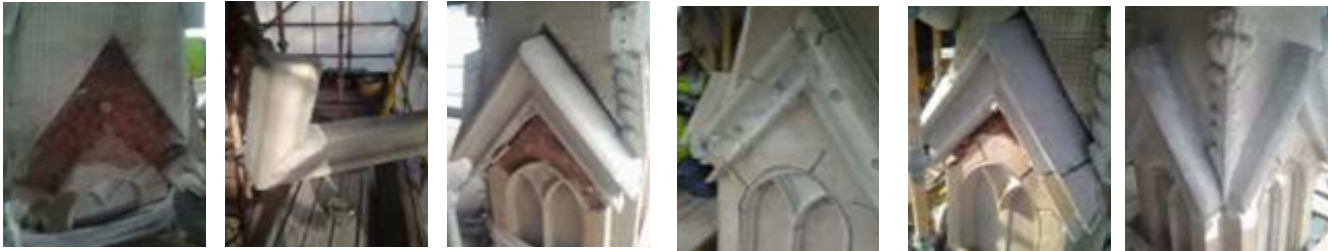
Canopy mouldings - Restoration:

Found at the base of each of the pinnacle tops were four canopy mouldings which appeared to have originally comprised of four parts. The canopy mouldings presented a lot of cracks and some of them had completely fallen off. Presumably shrinkage cracks had deteriorated over time thereby permitting the ingress of water leading to further deterioration.

The canopies that had failed were replaced with new one-piece precast units, cast from one of the failed originals, which were “hung” from specially adapted Cintec anchors which connected to a stainless steel plate cast into the back of the pre-cast canopy (All designed by T & G Ltd). Once in place the piece was further restrained with a further two anchors. All the other existing canopies were also secured using Cintec Anchors.

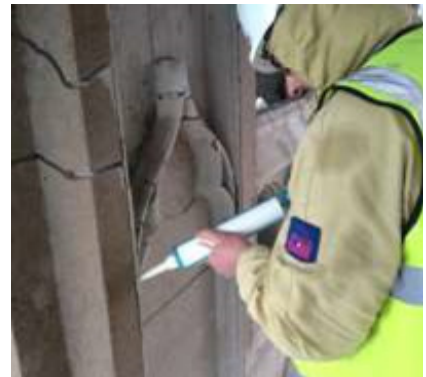
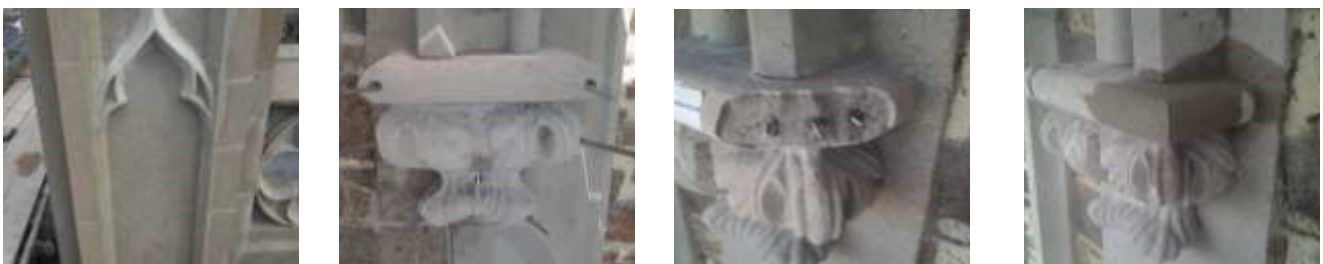
Mouldings - Restoration & Reproduction:

These exhibited a large amount of shrinkage cracking. On the side mouldings this was repaired through the prescribed crack repair method. In other places they were damaged by the spalling of steel wire reinforcement which had to be dug out, treated and repaired.

The cracks had their biggest impact on the tracery elements many of which had fallen away. These were replaced by new precast items that had 6mm stainless steel (A4) reinforcement and fixing pins cast into them that were then drilled and resin fixed in place with the joints being made with mouldable epoxy putty.
