Project: New Look, 6 King Street

Client: New Look

Architect: Anthony Gibb Ltd

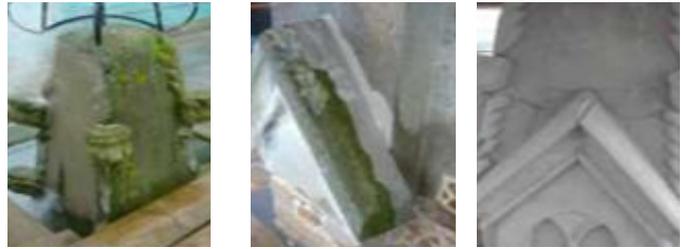
1st Stage - Cleaning

Garenne Natural Stone proceeded to remove the paint with the DOFF system and proprietary paint softeners. As the main entrance of the shop had to be kept open, Garenne Natural Stone installed a temporary system to cover the entrance, to protect the public and collected the waste water from the cleaning process above the entrance.

The DoFF System is a superheated water system (from Stonehealth) that uses a combination of low pressure and high temperature (up to 150°C) to remove ingrained dirt, biological matter and paint with minimal impact to the stone substrate (see photos right).

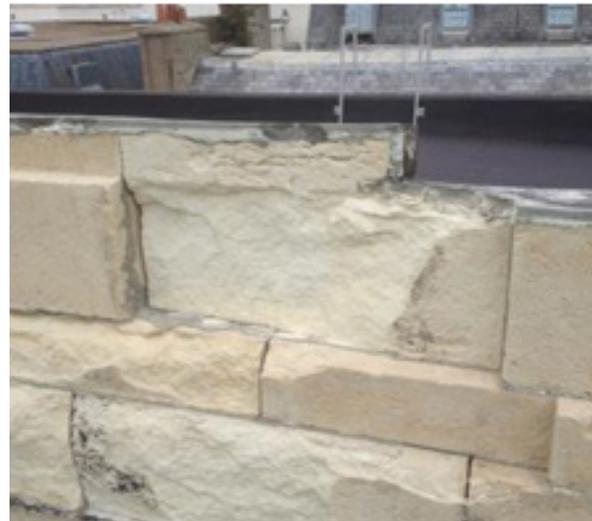
2nd Stage - Investigation/Report

The stone façade was found to have some deterioration due to:

- Old bitumen and layers of impermeable modern paint had caused deterioration of the stone by preventing moisture egress from the wall.
- Hard cement pointing further limited the moisture from finding a way out of the building and had caused damage to the edge of the stone blocks.
- Rusty steel beam had caused damage to the upper elevation (by expanding),
- Water penetration through the various cracks increased the deterioration of the stone and steel beams
- Poor previous repairs made with harder material (cement) had fallen out by delamination.

The selection of the replacement stone began with assessment of the existing stone by the Island's Geologist. Once identified, Garenne Natural Stone has investigated and submitted the selection of replacement stone to the Historical Officer and Architect for approval: Limestone selected is Marnhull.

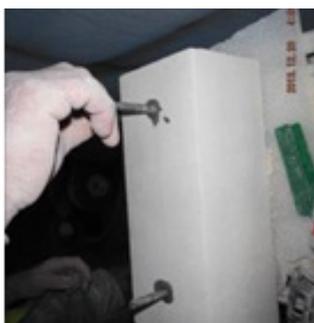
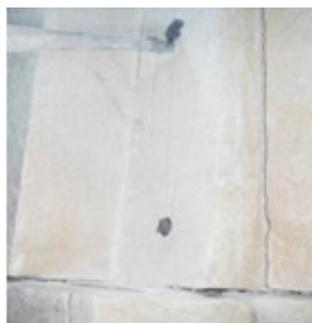
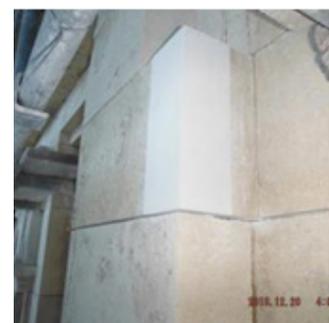
B. Replacement of Sections of Stone

This was undertaken where the stone had fallen away in larger chunks but there still remained the majority of the stone in place which was sound and stable and it was possible to 'indent' a new piece of stone, carefully sourced to match existing and to replace the missing portion.

The method consists of digging or cutting out the stone and then cutting a square 50mm depth new cladding piece, installed by pinning and grouting the back.

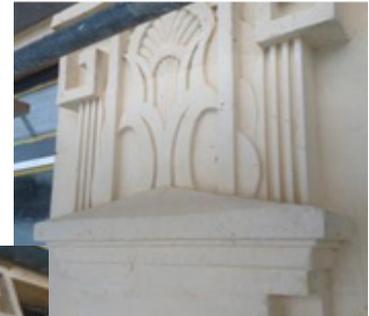
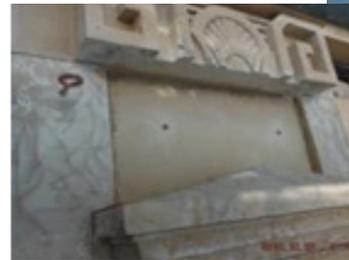
D. New Carved Stone

One of the existing carved stones was in a very poor condition and had to be replaced entirely. Mark Guest (Stonemason) reproduced a new carved stone copying the existing. The second carved stone was kept and partially repaired using mortar repair.

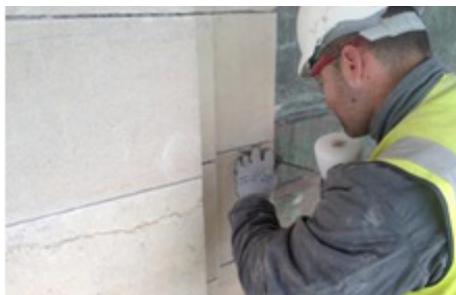
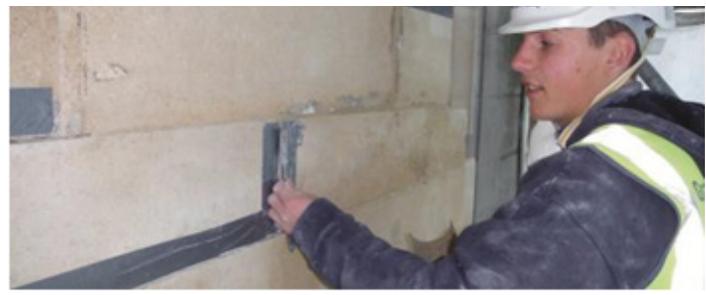
E. Lime Pointing

The pointing generally needs to be softer than the stone to allow the moisture to pass through the pointing and not through the stone. The existing cement pointing was raked out (4/6mm width and 15/20mm depth) and repointed using a mix of (1/2/1): NHL/Sand/stone dust. The stone dust was produced from the existing damaged stone.
