Bank stabilisation Case Study

River Great Ouse , Buckingham

Chandos Park Project

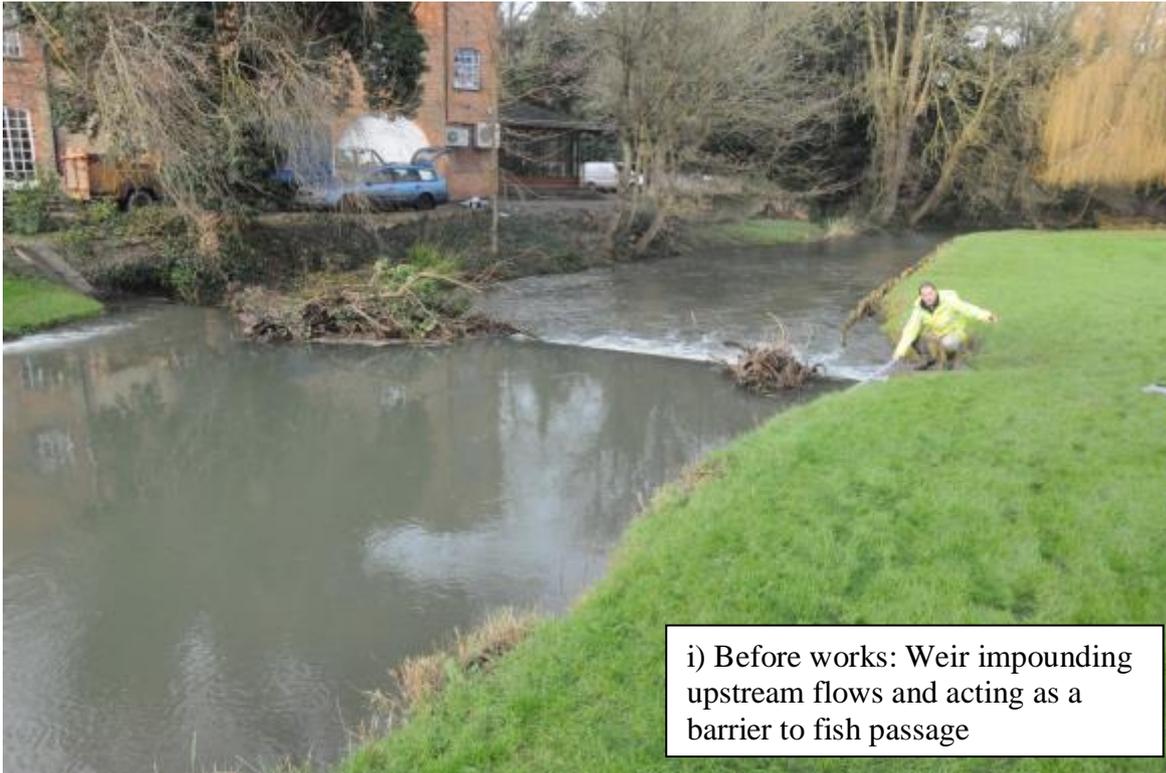
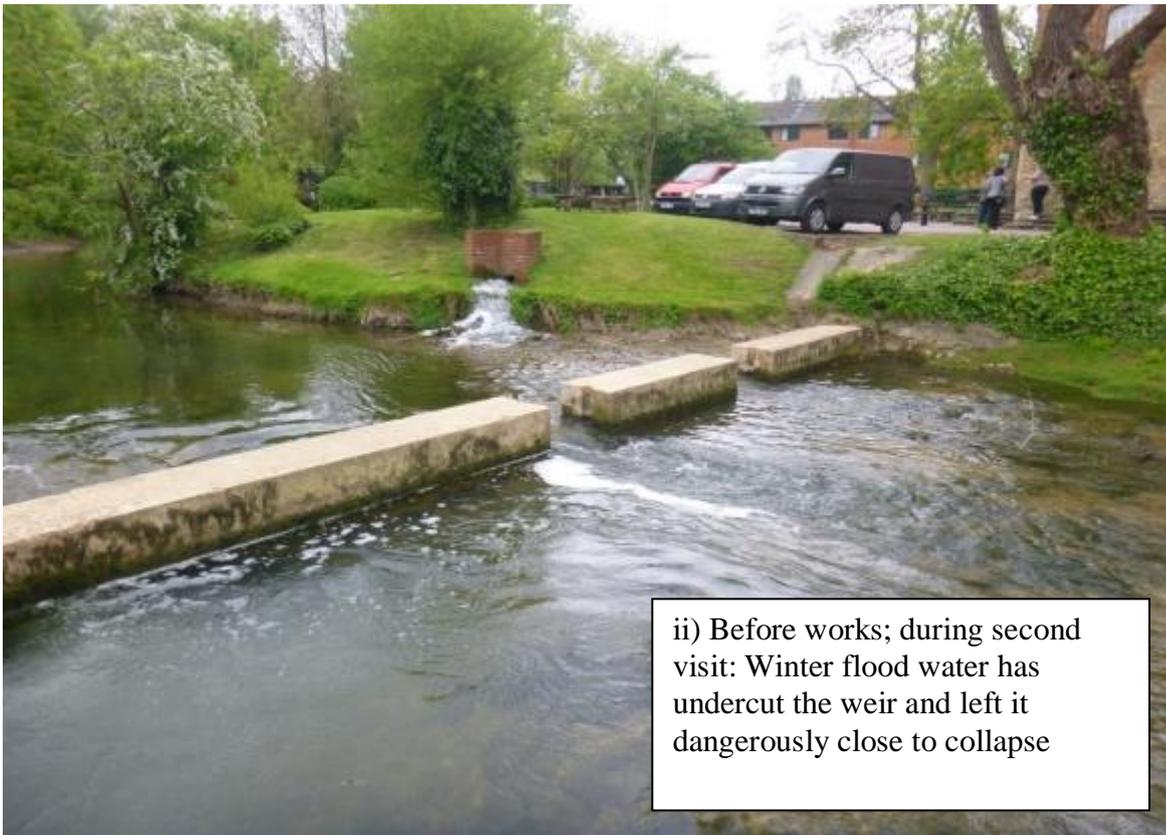
The weir itself failed during the winter of 2016 as it was undercut by floodwater leaving the top of the weir exposed above water level and the structure unsupported in the middle, this was a risk to the general public and required immediate removal.

The first stage of works involved the removal of the weir which had been undermined and was close to structural failure. A 13t excavator with a breaker attachment was used to break the concrete into manageable pieces, then place them into a tracked dumper for removal.
