<b>Name</b>	<b>Job Title</b>	<b>Signature</b>	<b>Date</b>
<b>Application made by:</b>	SCS	<b>Section engineer Environmental Advisor</b>		10/12/2019
<b>Location (Sector/Site Name) and address:</b>	Park Village East (PVE), Euston Scissor Box, Euston Approaches, HS2			
<b>Nearest postcode / Grid references</b>	NW1 7SN			
<b>LAA/LAP/Site Reference</b>				
<b>Date of Tree Panel:</b>	01/01/2020	<b>Meeting No:</b>	24

**Site Description:****Park Village East Wall and Planter**

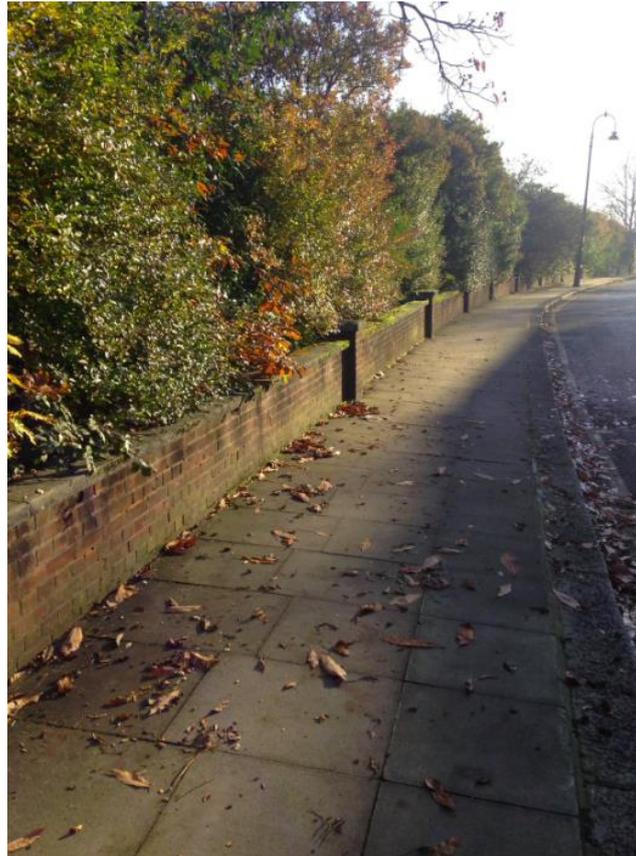
Figure 1: Image of the PVE Planter North of Mornington Crescent bridge

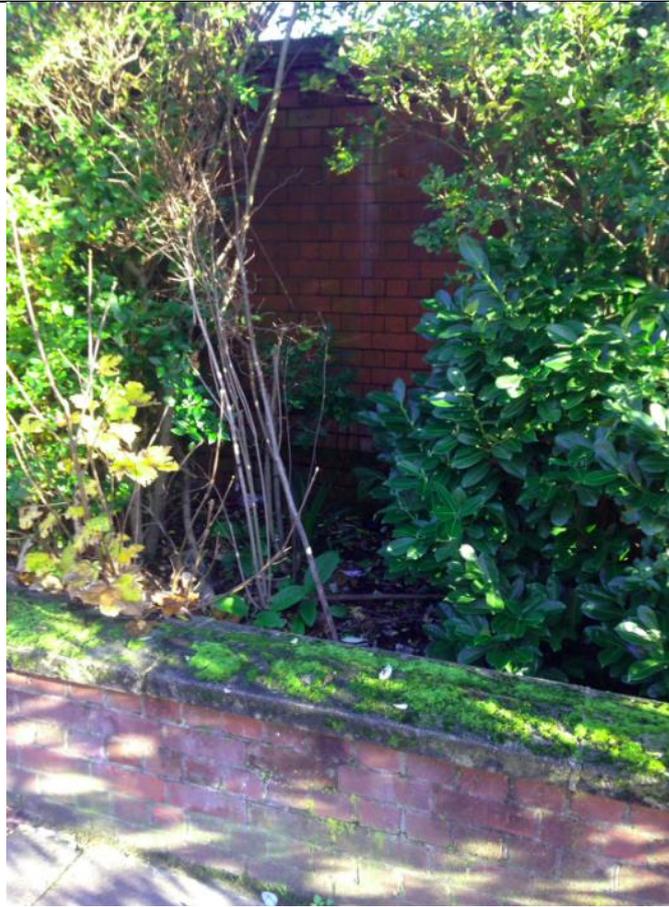
2no. past Surveys have been carried out on the southern section of the PVE Wall. This past survey/assessment condemned the PVE wall up to the CSJV Haki staircase in the southern section of PVE. The demolition of the wall down to a safe height found that the bonding capacity of the mortar was poor. Bricks could easily be removed by hand & mortar could be crumbled between fingers. A structurally unsound brickwork wall poses obvious health and safety risks for future works within the SCS site below.

Therefore, due to the conclusion of the previous surveys undertaken and potential health risk, further investigation is required for the remaining 'northern' section of the PVE. This is currently extremely difficult to carry out due to the vegetation within the planter.

Figure 2: Image of PVA Wall to be surveyed. Vegetation and trees causing issues to properly survey

<p><b>Proposal Endorsed/Not Endorsed:</b></p>	<p><b>Not endorsed</b></p>
<p><b>Conditions</b></p>	<p><b>Tree removal not endorsed, however, tree pruning where required to survey the wall is endorsed. Expectation that shrub removal will also be carried out without excavation.</b></p>
