| Location (Sector/Site Name): | Sector 1 | | | |
| LAA/LAP/Site Reference | Granby Terrace Bridge Utility Diversions | | | |
| Work Package number: | Po81 | | | |

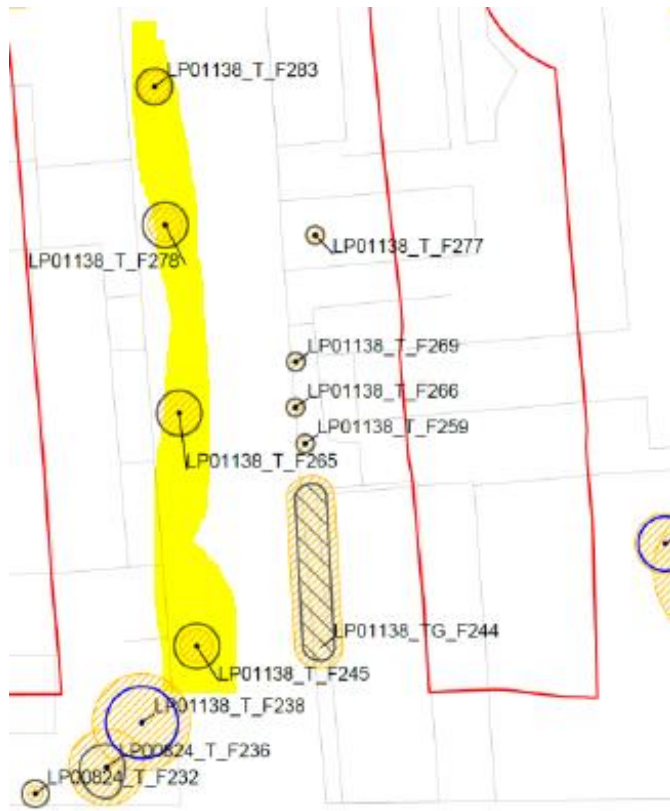
| Reason for clearance: | The purpose of the vegetation removal is to allow access for the excavator to carry out works associated with the Utility diversions around Granby Terrace Bridge. The tree's sit less than a metre from the edge of the utility trench, preventing the excavators from being able to work. The tree roots are at threat from extensive damage during the excavation works. | | | |

The 4 trees on Harrington Street that require removal.

| | | Proposal Endorsed/Not Endorsed: | Endorsed with conditions |
|---|---|---|---|
| Conditions | <ul style="list-style-type: none"> -Site visit with HS2, CSJV, and LBC shows that the Norway Maples cannot feasibly be retained. -CSJV to update on timing of removal to allow for a community response to the proposal. -CSJV to pursue replanting in the area if possible. | | |

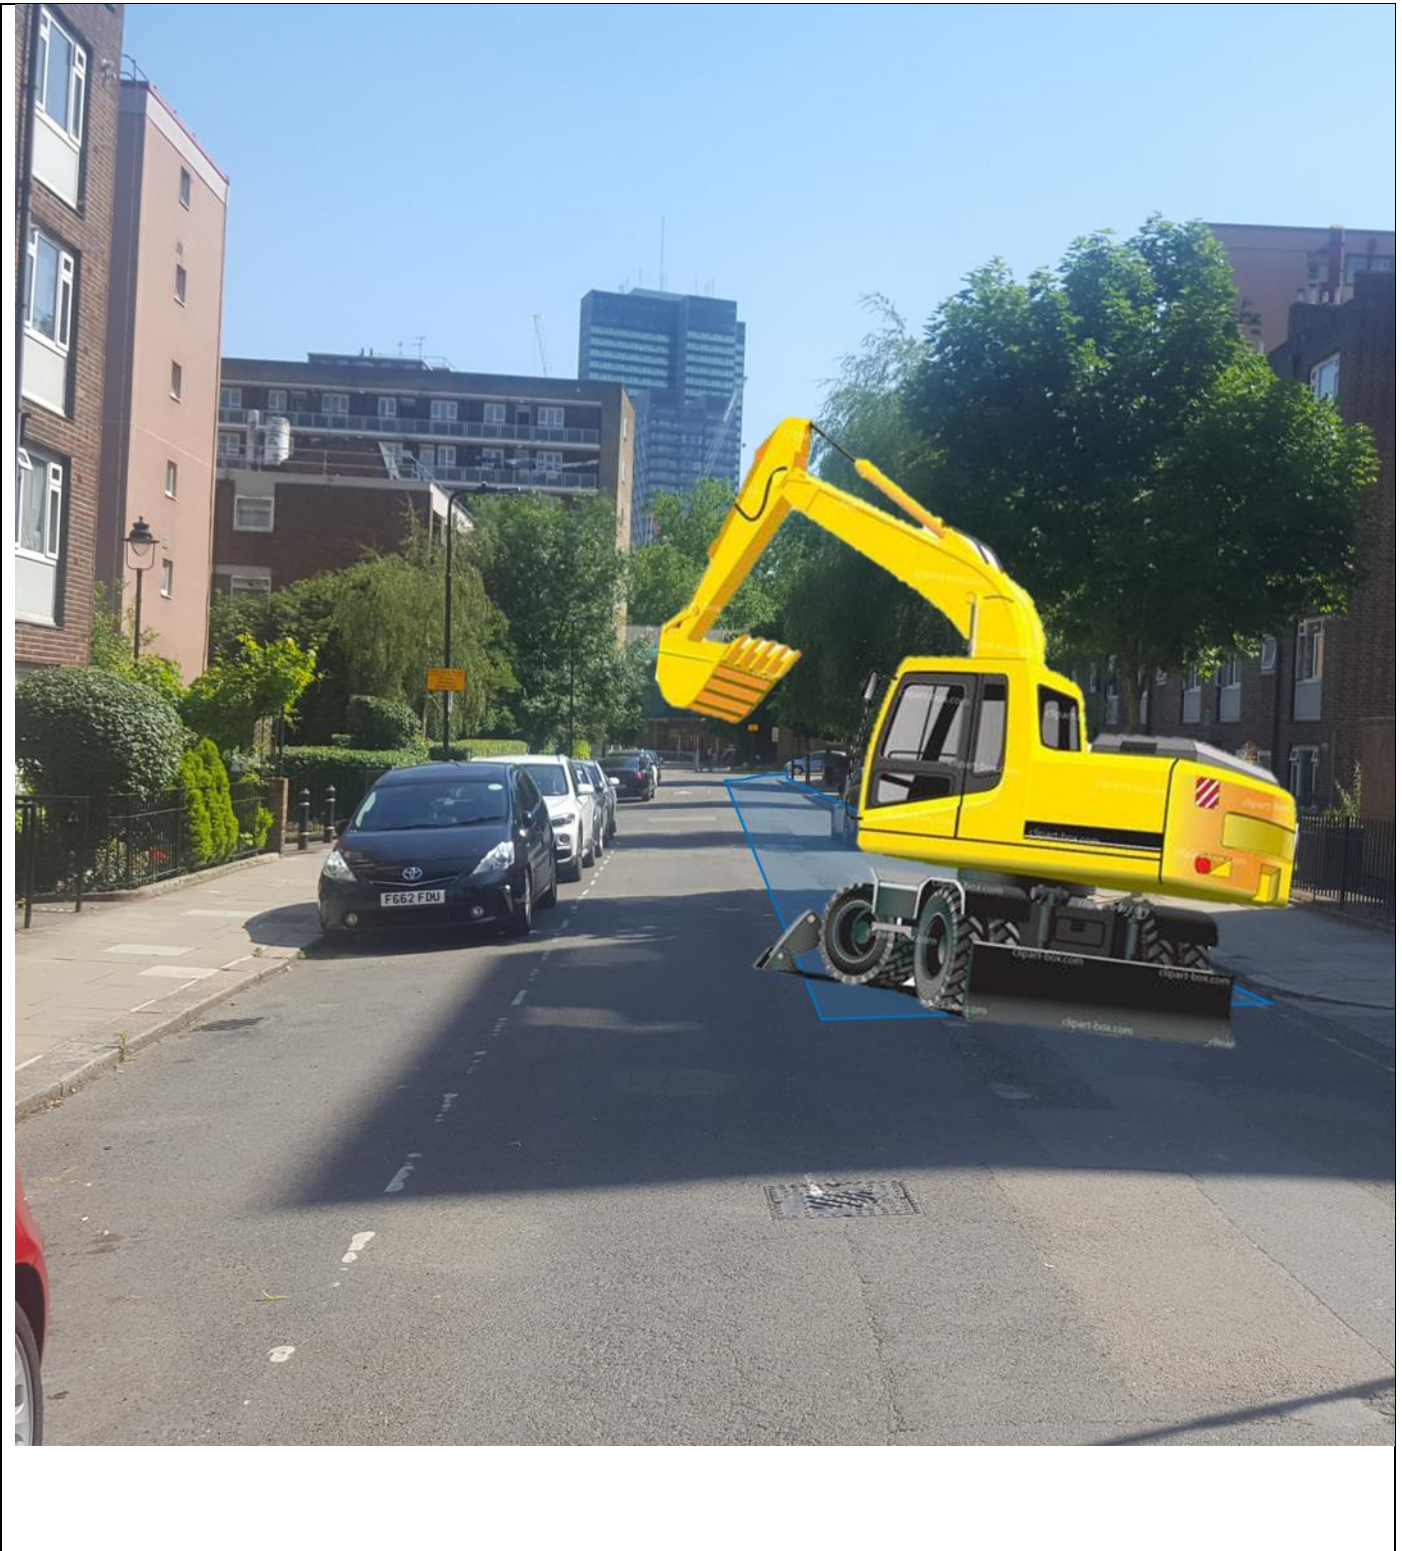
| Tree ID | Species |
|---|---|
| LP01138_T_F283 | Norway Maple |
| LP01138_T_F278 | Silver Birch |
| LP01138_T_F265 | Silver Birch |
| LP01138_T_F245 | Norway Maple |
