Water Vole Survey Report

Parc Solar Traffwll, Anglesey

September 2020

Wychwood Biodiversity Limited

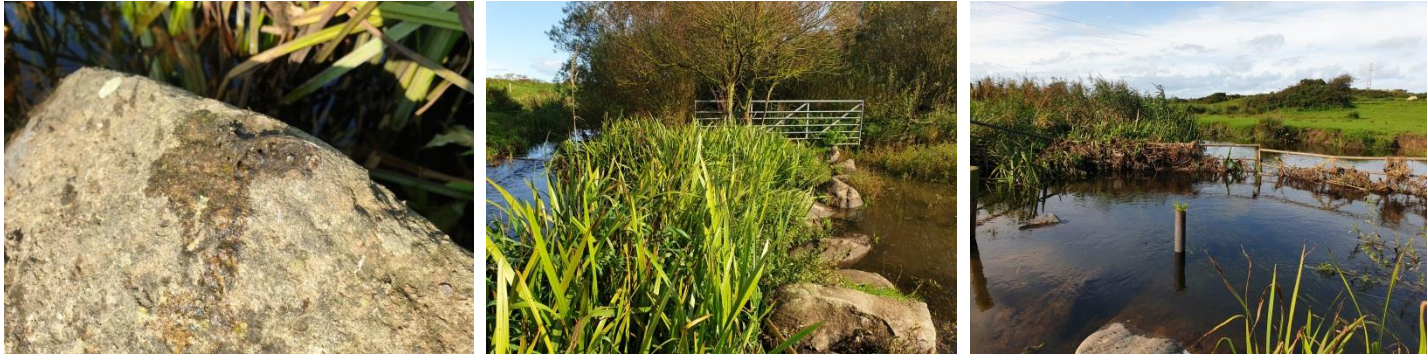
- A. East end of the water course surveyed there is a pool of water with large rocks. 4 fresh otter spraints found on rocks, one very fresh probably from the previous night.

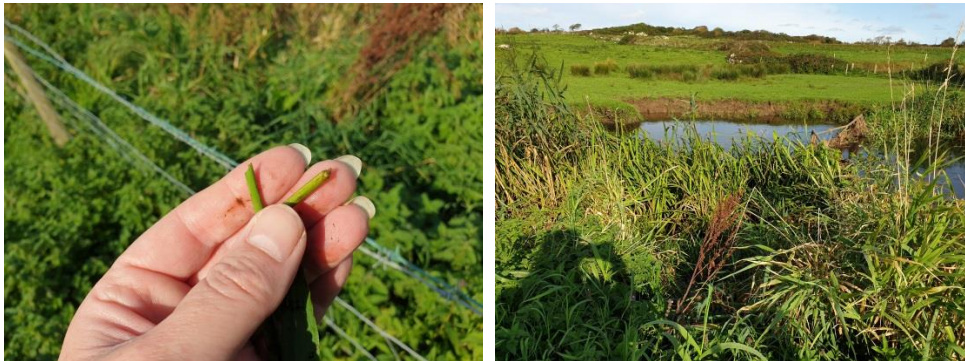
- B. Feeding station on vegetation on southern bank just into vegetation from the pool area. Water levels high and over the bank in this section.

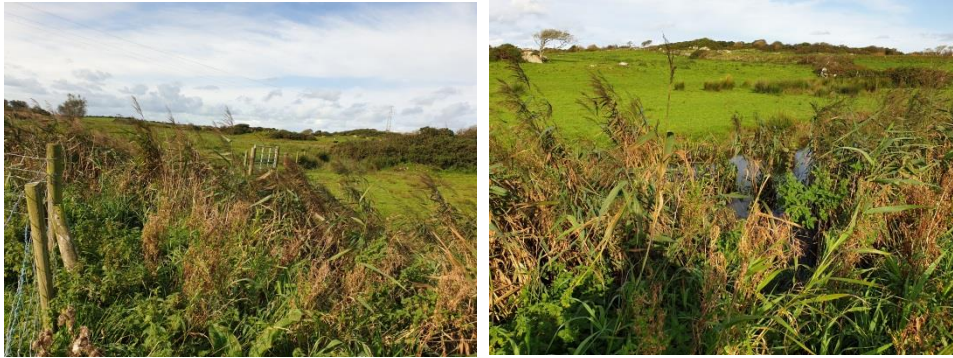
- C. Floating feeding stations in amongst the reeds as well as plenty of individual bits of cut vegetation that were probably piles before the water level rose. At least 4 floating feeding stations and 1 on the bank in the reeds. Opposite bank is grazed short.

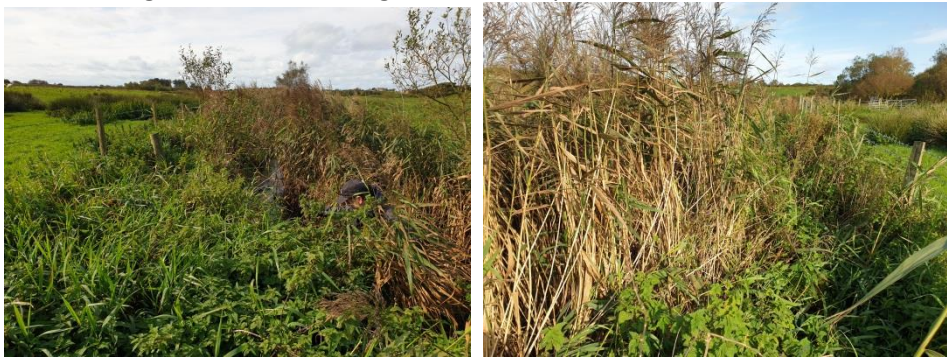
- D. Section from fence line on northern bank to slight bend in the water course. The vegetation on northern bank is longer here than the previous section. Feeding station with old vegetation on the bottom and fresh on top in the reeds. Fresh feeding stations in the water course. Field vole signs along bank, on platforms with feeding remains. After the slight bend the water gets much deeper.

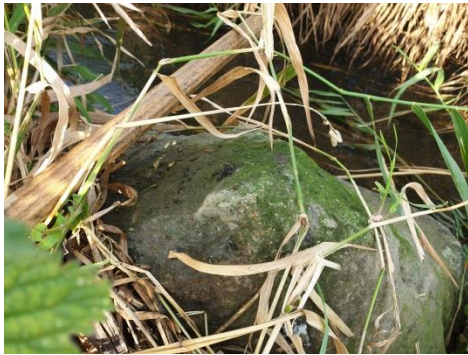
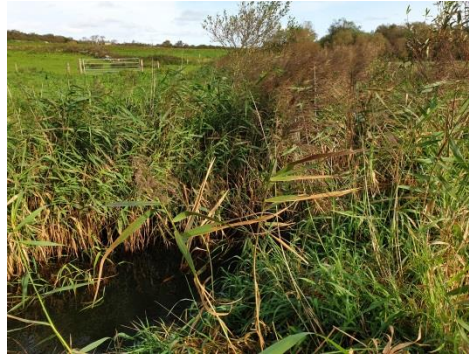
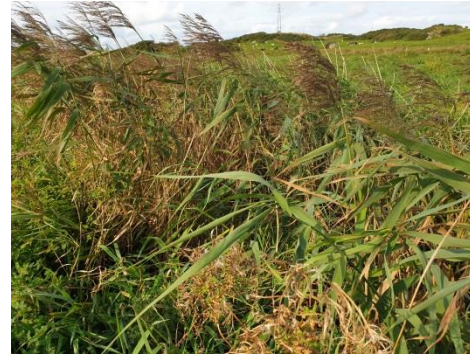
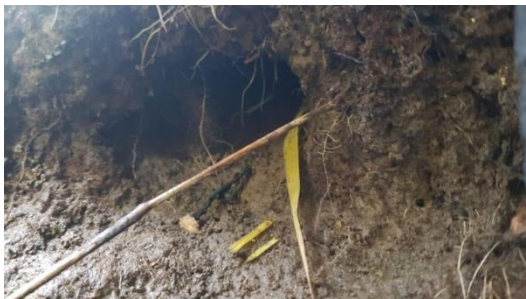
- E. Otter spraint on top of large boulder on bank side.
1 latrine found, with some trampling + burrow in bank.
Feeding stations found in the reeds and cut stems floating in the water.

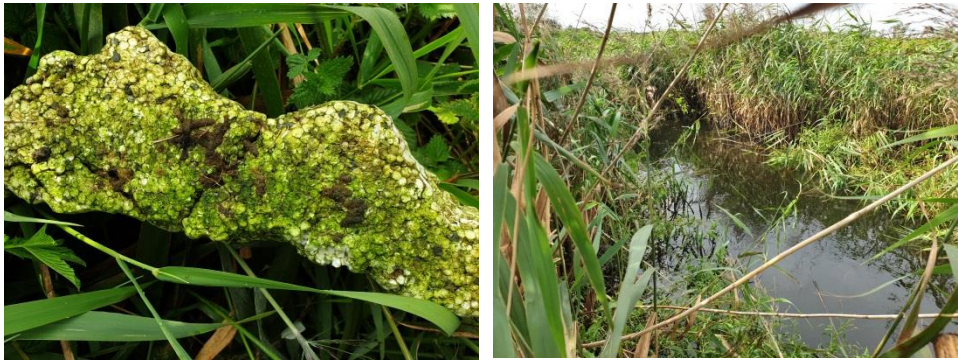
- F. Polystyrene in water with water vole latrine on.
Numerous feeding stations in the reeds.

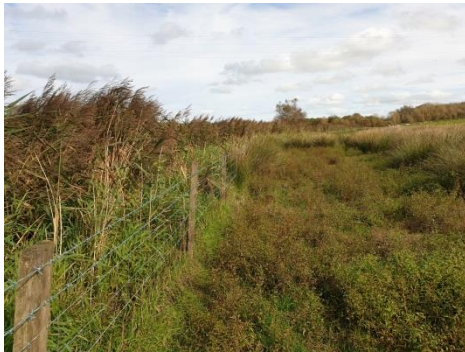
- G. Feeding stations within the reeds and floating vegetation also field vole feeding remains higher up in vegetation.
