# Bother on the River Rother!

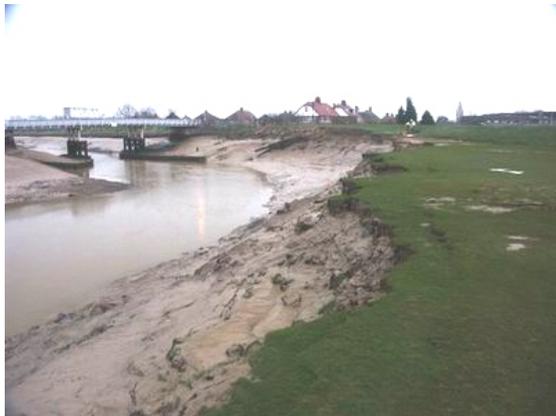
Slumping bank - site of emergency works

on reclaiming its saltings. Whilst these processes enable an unconstrained river system to adapt to changing flow and sediment regimes, in a severely constrained one, these same in-channel changes are often a cause for concern. In an ideal situation the levees would be set back allowing the river to reclaim its floodplain, reducing the stress on banks. Extensive floodplain development prevents such an holistic approach at present and some banks are so degraded that emergency protection is essential to prevent a complete breach of the existing defences.

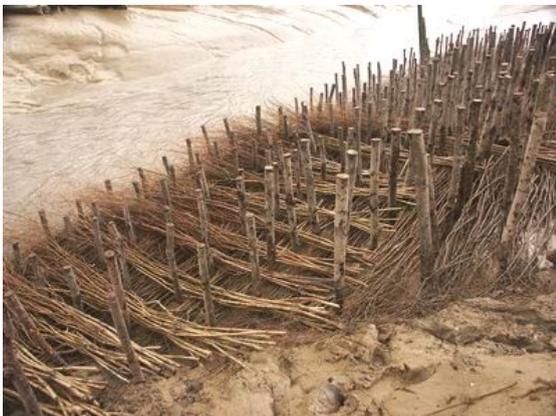
Trial construction: more faggots than you can shake a stick at.

to protect and stabilise banks, create new marginal habitat, and crucially, to trap silt, has been demonstrated. So when asked to provide an environmentally friendly, sustainable and cost effective alternative to sheet piling for the emergency bank protection work at Rye, Simon Cain thought big and adapted his relatively small brushwood structures for the job. A trial project was rapidly constructed to demonstrate the principles of the new technique. Within weeks of completion the bottom half of the structure was completely full of sediment with no noticeable adverse effects.

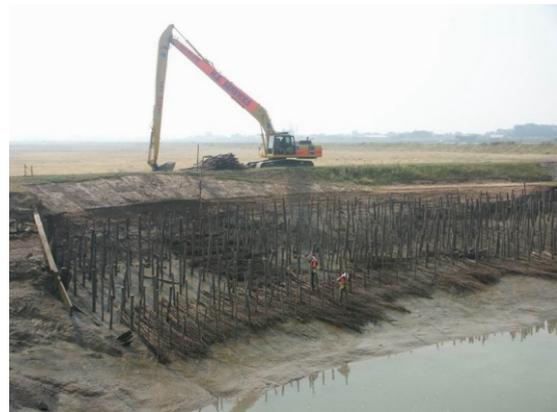
22m reach Komatsu and two faggots shows scale of works.

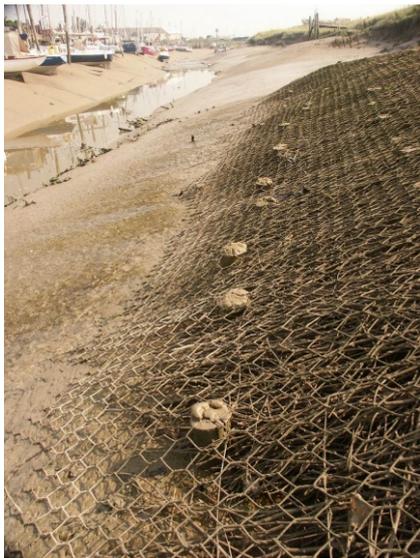
*Sedimentation at trial site*

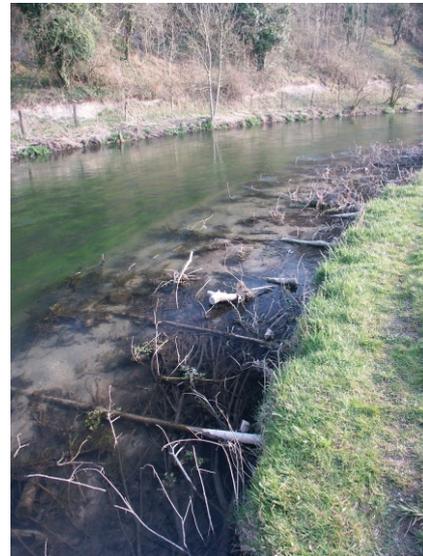
*Brushwood mattress on a chalk stream*

More recently, similar brushwood techniques have been successfully used by the Cain Consultancy to restore chalk streams and spate rivers. Their ability
