Project: New Look, 6 King Street

Client: New Look

Architect: Anthony Gibb Ltd

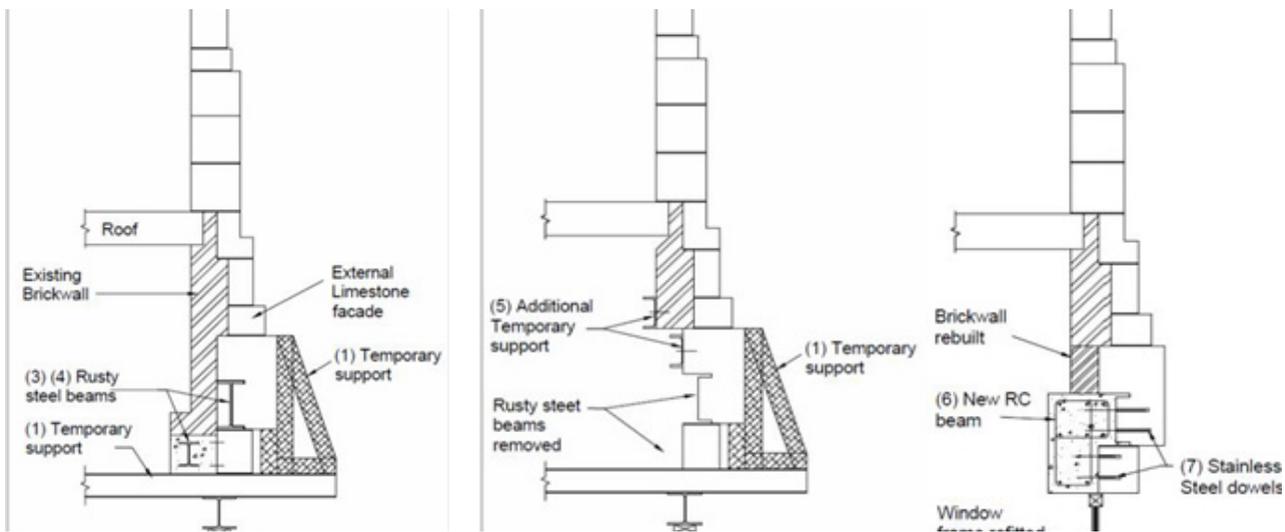
Casting in-situ reinforced concrete beams (6) with previously resined in stainless steel dowels into the back of the stone (7).
