CARBON SIX
HOME INSPECTIONS

Sample Home Inspection Report

2112 Walnut Ct.
Walnut Hills ST
12345

Date of Inspection: 10/22/2015

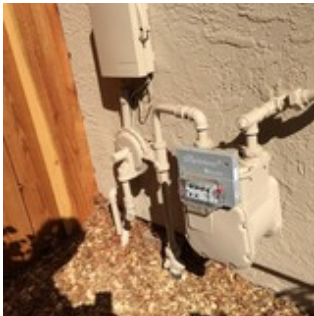
Gas

Serial #: 49218854
Reading One: 1225
Last Checked: September 22, 2015
Supplier: PG&E
Location: Left front

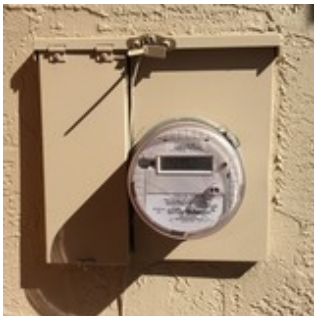
Electric

Serial #: EE30015474
Reading One: 44091
Reading Two: 0.762
Last Checked: September 22, 2015
Supplier: PG&E
Location: Left front

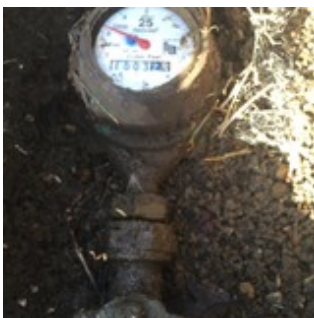
Serial #: M25
Reading One: 1003.26
Last Checked: July 03, 2015
Supplier: CC Water
Location: Front sidewalk

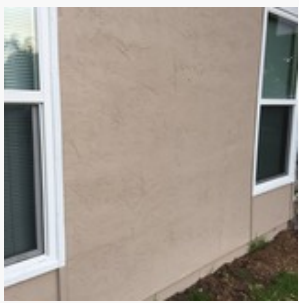
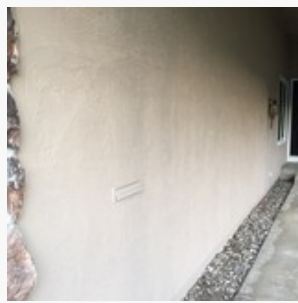
Stucco

Small surface cracks were repaired prior to October 2015 exterior house repaint.

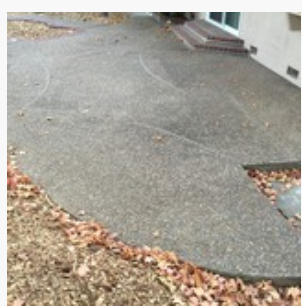
Concrete Hardscape

Serviceable. Prior in-ground spa has been abandoned and filled with dirt/rock and topped with wood chips.

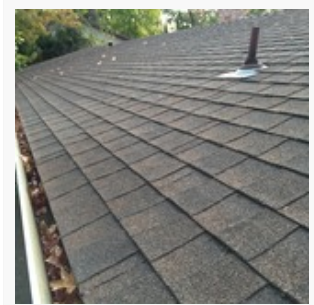
A detailed Roof Inspection has been ordered and has therefore not been included in this report. General photos of roof to show visual condition.

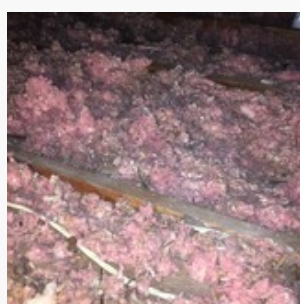
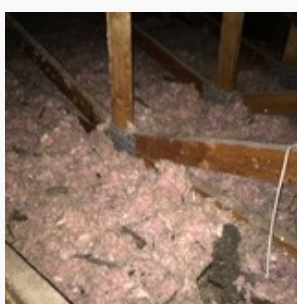
Insulation

Inspected; OK

Blown insulation throughout.

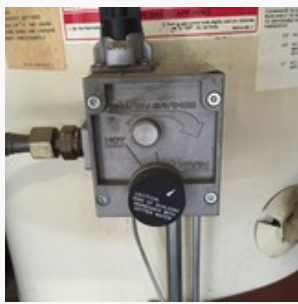
Main Gas Shutoff (continued)
Water heater located in garage. Shutoff easily accessible.

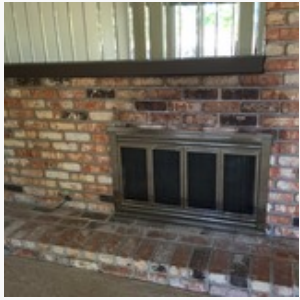
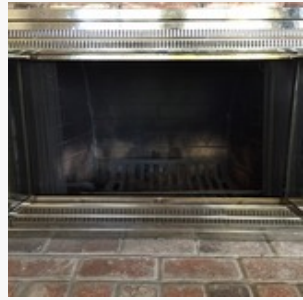
Fireplace(s) / Fuel-Burning Appliances

Gas starter / wood burning fireplace. Flue clean and clear based on visual inspection from hearth.
